# MULTIPLE LINES SURVEY REPORT ©

Insured: **GRANDVIEW PROFESSIONAL CENTER**

Survey Date: **15-MAY-2003**

Location Surveyed: **1701 WEST SLIPPERY ELM DRIVE**

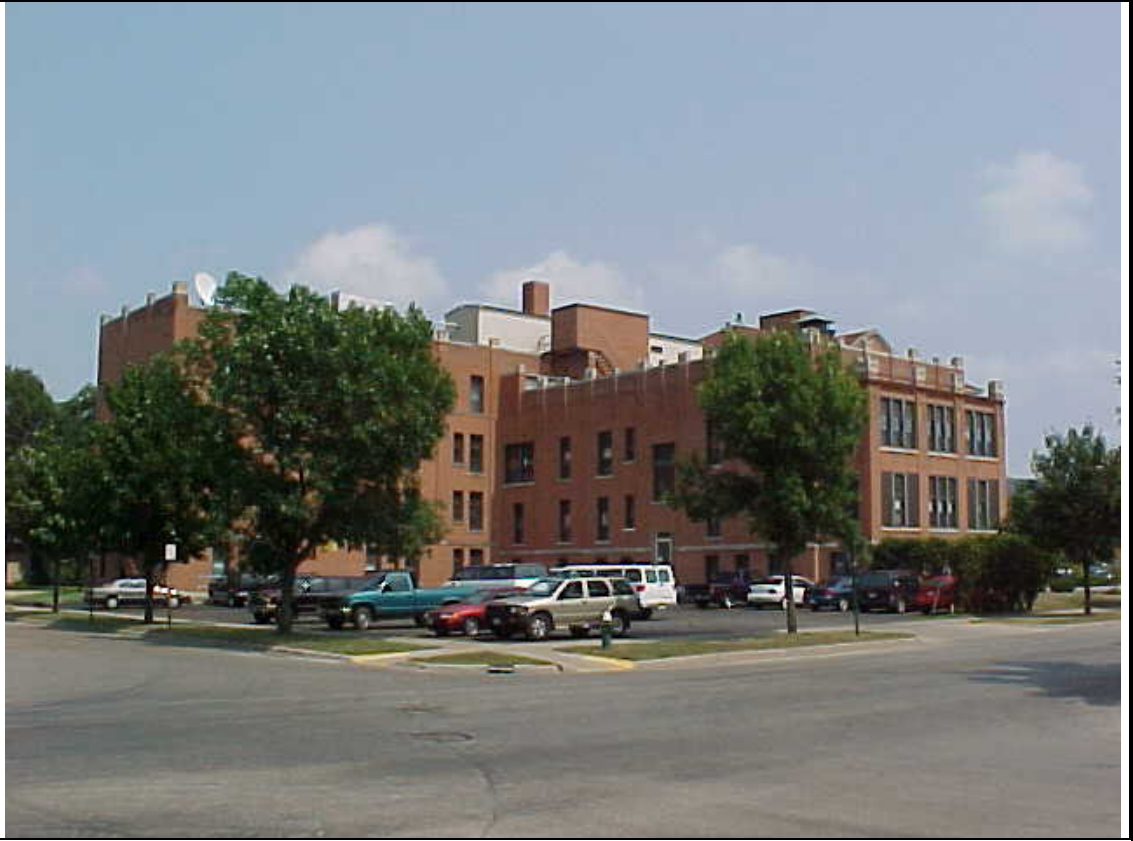
Photo No: **1**

**SOUTHWEST ELEVATION VIEW**

Shows the three (3) and four (4) story sections.

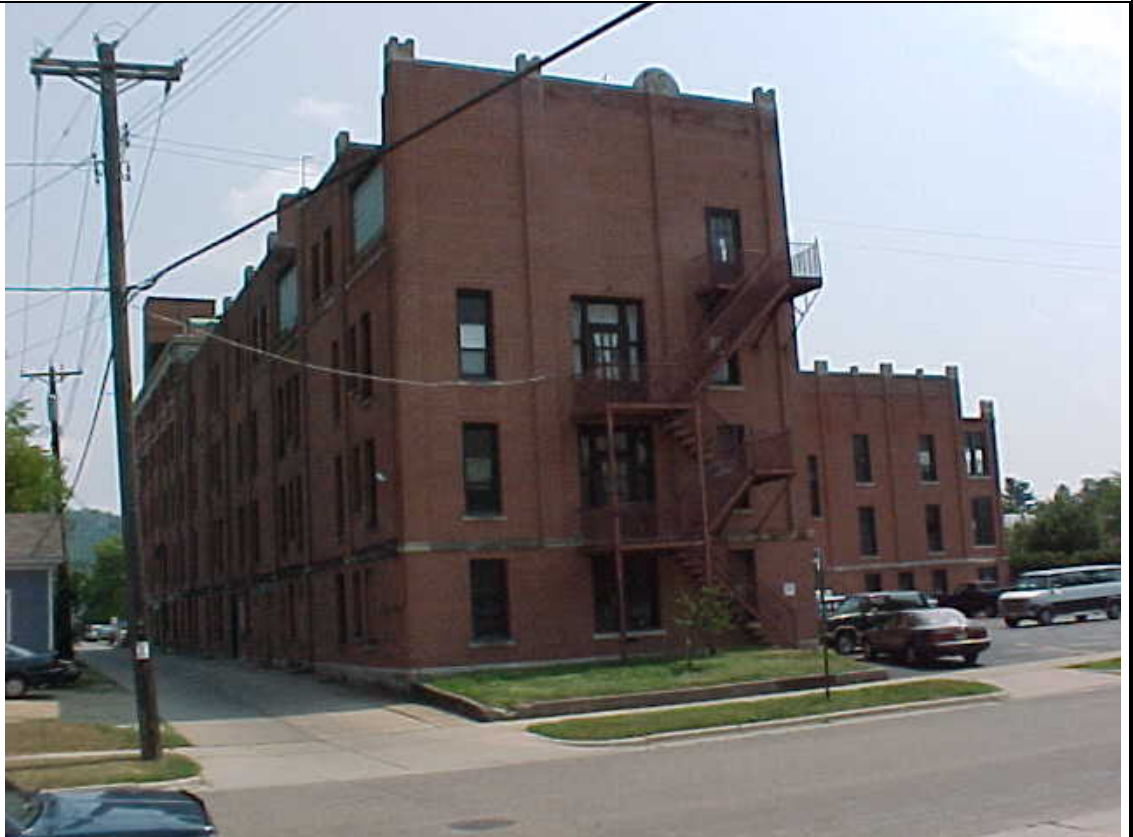
Photo No: **2**

**NORTHWEST ELEVATION VIEW.**

Shows the exterior fire escape stairs and rear wall abutting the public alley.

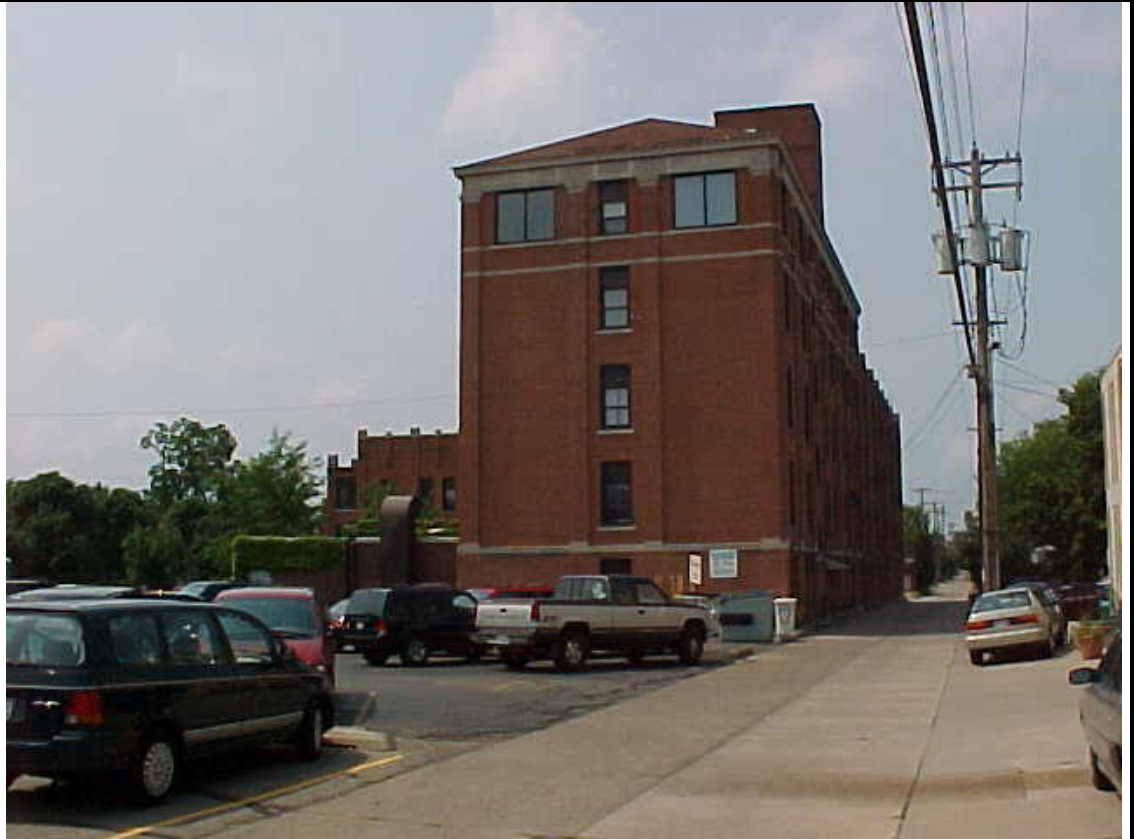
Photo No: 3

**NORTHEAST ELEVATION VIEW**

Shows the five (5) story section and the rear wall area that abuts public alley.

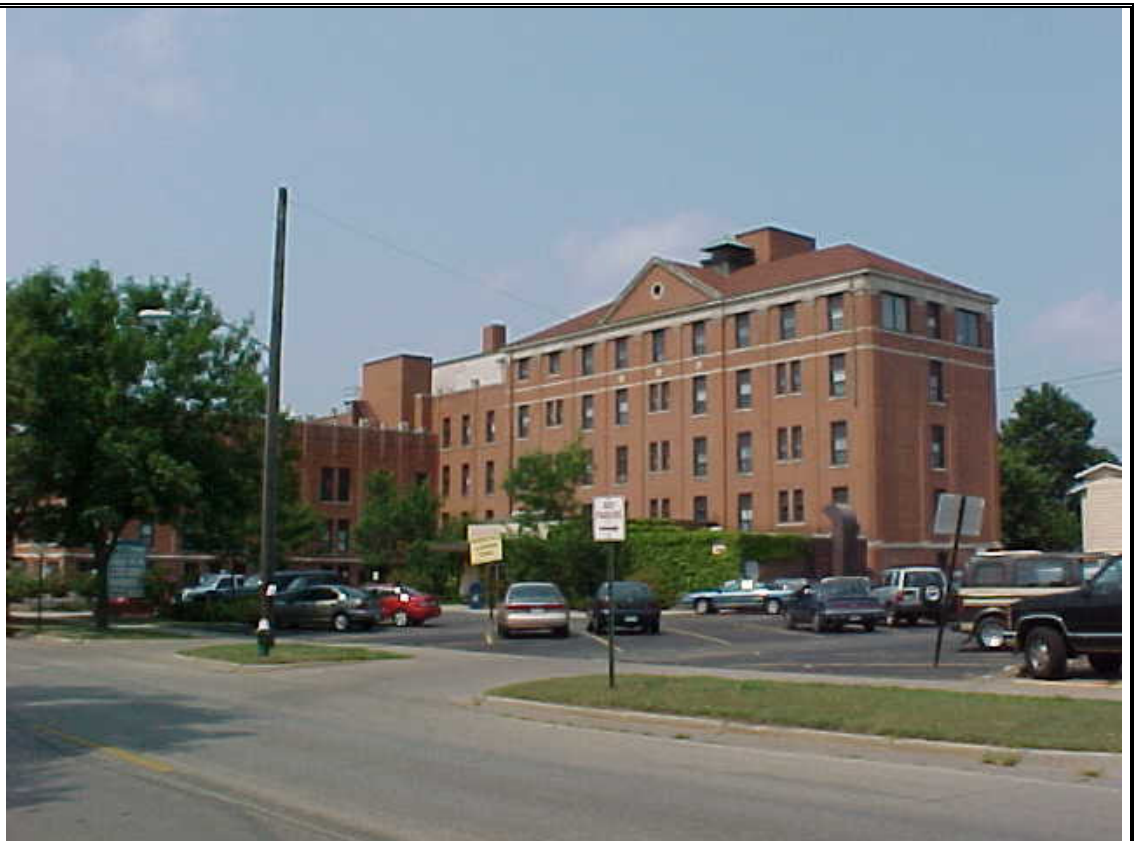
Photo No: 4

**SOUTHEAST ELEVATION VIEW**

Panoramic view of the five (5) story section, three (3) story section and the one (1) story section (covered with vines).
