APARTMENT PROPERTY & LIABILITY SURVEY

Insured: SUMMER HILLS APARTMENTS, INC.
Mail Address: P. O. BOX 888-A
City-State-Zip: LAKE BARTLETTE, MN 55999

Policy Number: 5549-1112
Survey Date: 26-FEBRUARY-2003
Surveyed By: JOHN CASH REGISTER

Survey Location: JUNCTION 2ND AVENUE & 1ST STREET
City-State-Zip: LAKE BARTLETTE, MN 55999

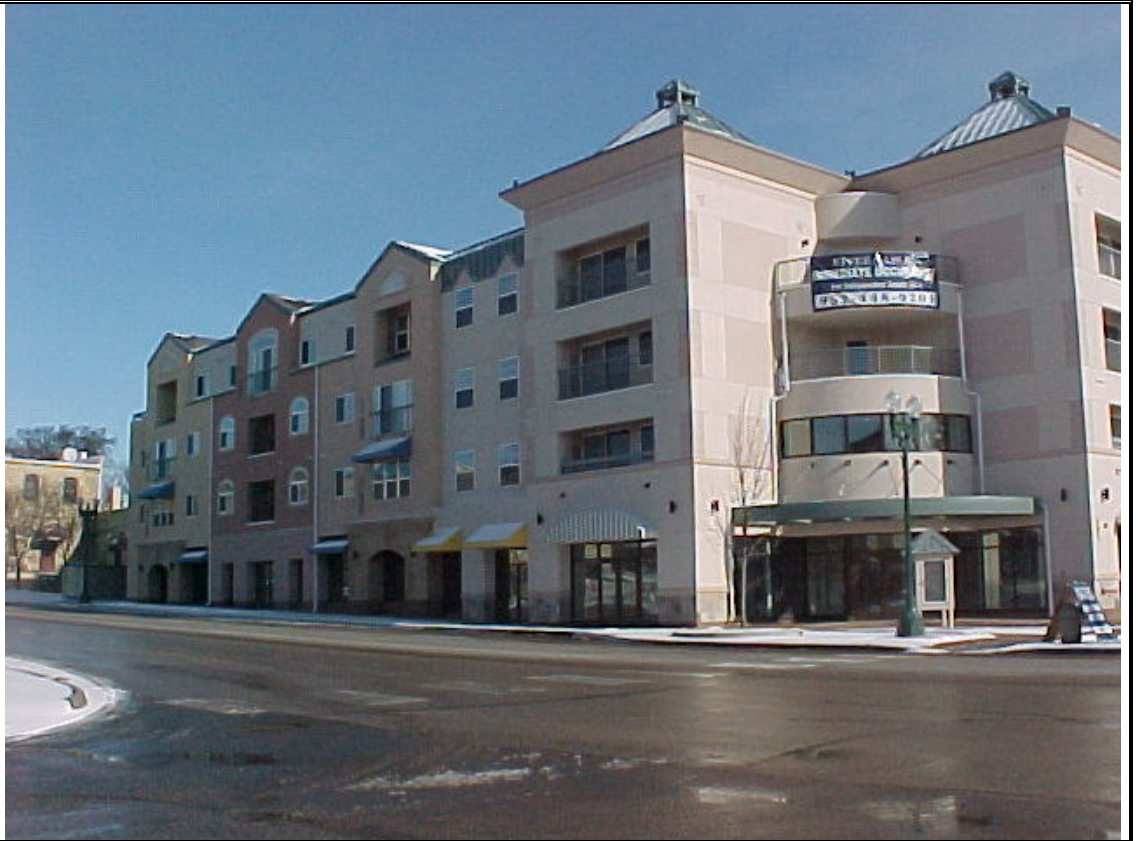
Special Note:

First floor only has masonry walls. All other walls are wood frame.

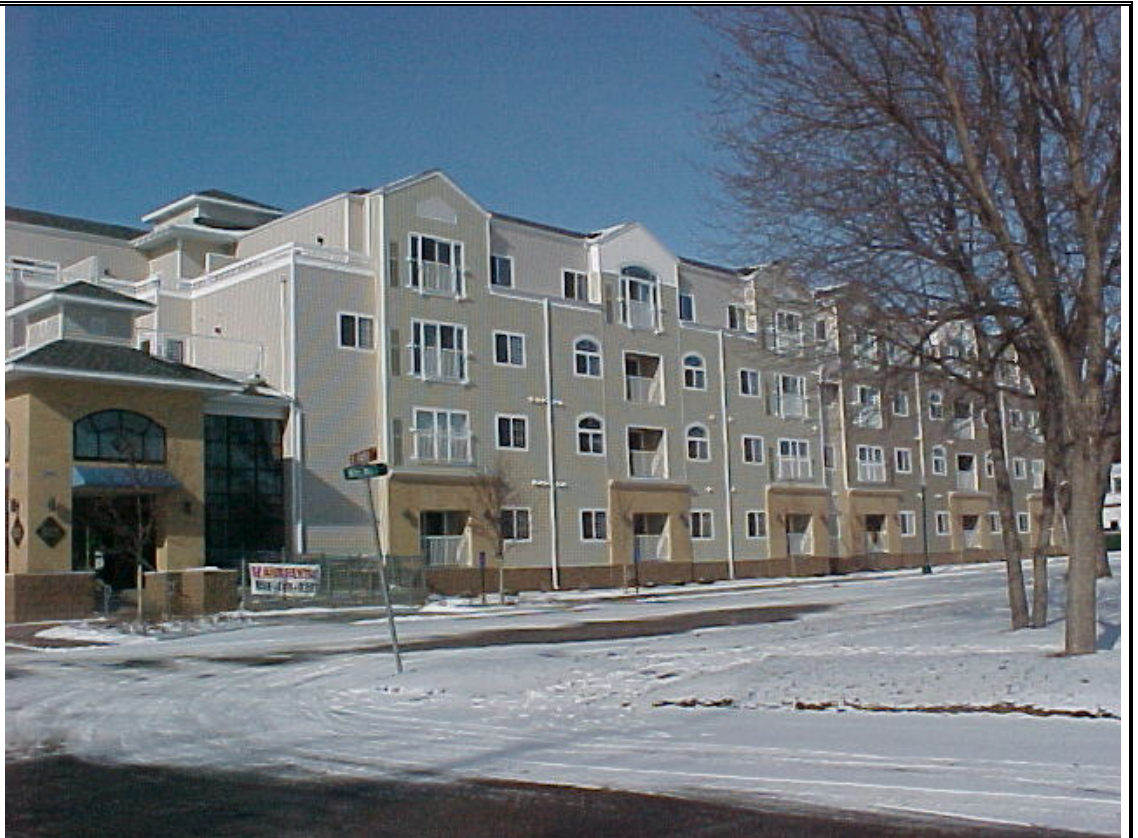
Photo No: **2**

REAR ELEVATION

Special Note:

Rental office is on left side of photo. It is open through the second floor level.

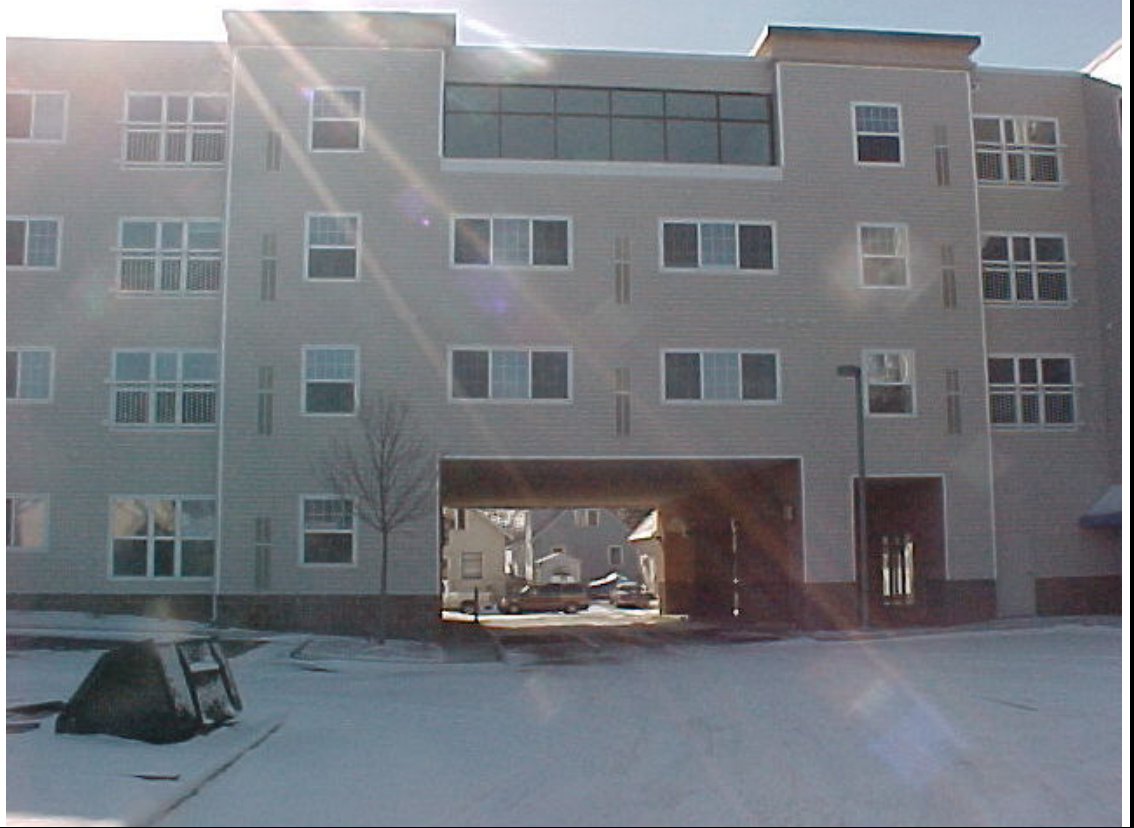
Special Note:

**This is only access way to
parking area and garage
entry.**
